Navigation Systems Research Program

Assessing Corrosion Damage and Corrosion Progression in Multistrand Anchor Systems in Use at Corps Projects

July 2013

Final report

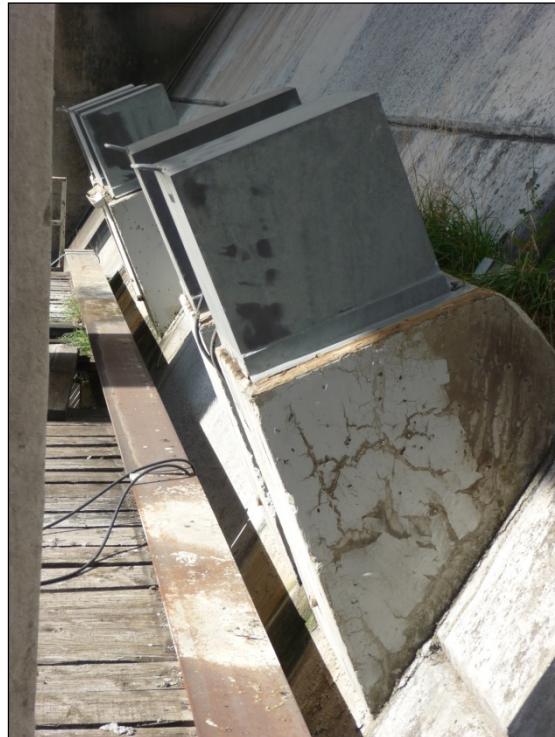
Figure 6-5. Covered anchor head at John Day.

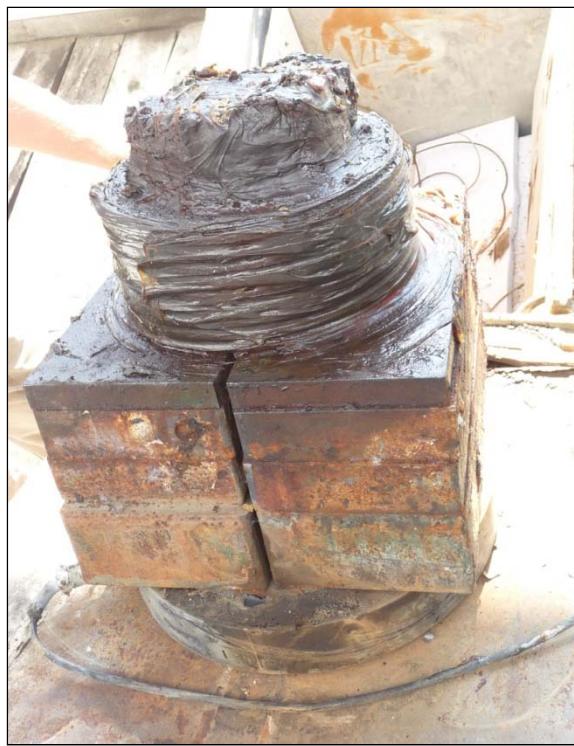
Once the shim stacks were removed, both anchor heads looked similar. A feeler rod was used to locate the grout in the trumpet. In both cases, no grout was detected. The grease appeared highly contaminated. In the upper section, it was red from rust products and, in the lower section, water and possible mildew had turned it black. Figure 6-7 shows the

Figure 6-6. Anchor head before removing shim stack.

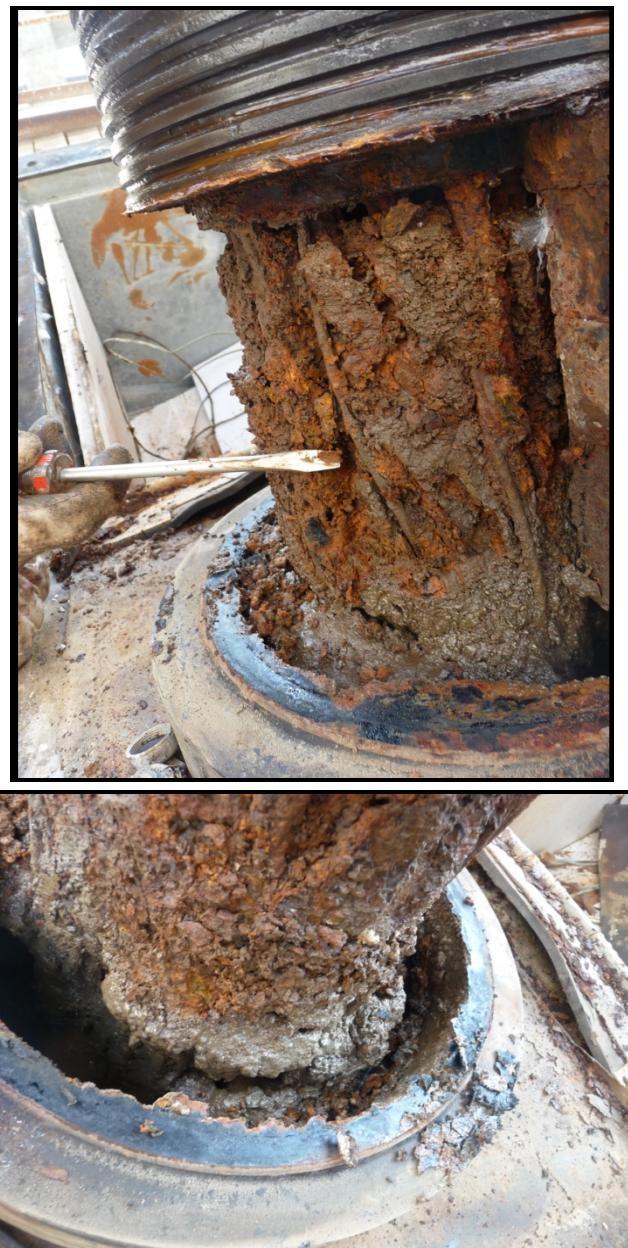
contaminated grease. The grease with more rust product is stiffer and, as one moves down from the top of the anchor head, the grease is water saturated and softer.

Figure 6-7. Wet grease with rust and possibly mildew contamination (top) and the voided perimeter section (bottom).

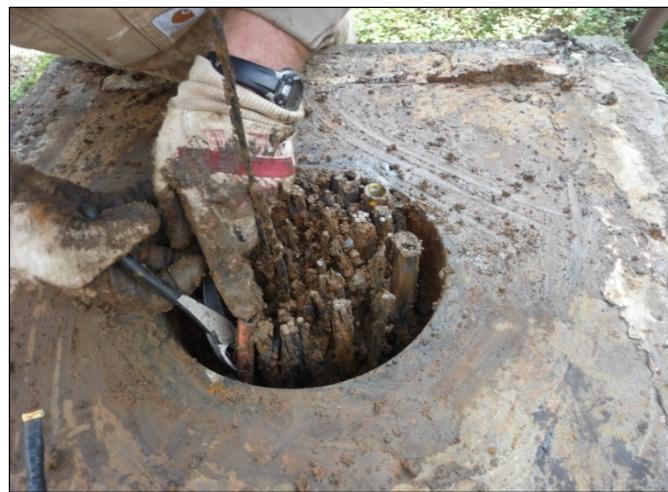
Figure 6-8. Anchor head removed for shipment to ERDC-Vicksburg.

Found in the anchor heads were tubes of different colors and materials. In Figure 6-8, the red packer air line is being cut. Also observed were rigid tubes that were yellow and blue. It is believed these are grout and possibly vent tubes. During lockages, it was observed in both anchor heads that the mass volume of water was traveling up the yellow tubes. This flow is indicated by the arrows in Figure 6-9. No other water seemed to be entering the trumpet, except from the path of these yellow tubes. This new information changes the perspective of the 1982 inspection report and the 2008 Cornforth report that the water was traveling up the strand itself.

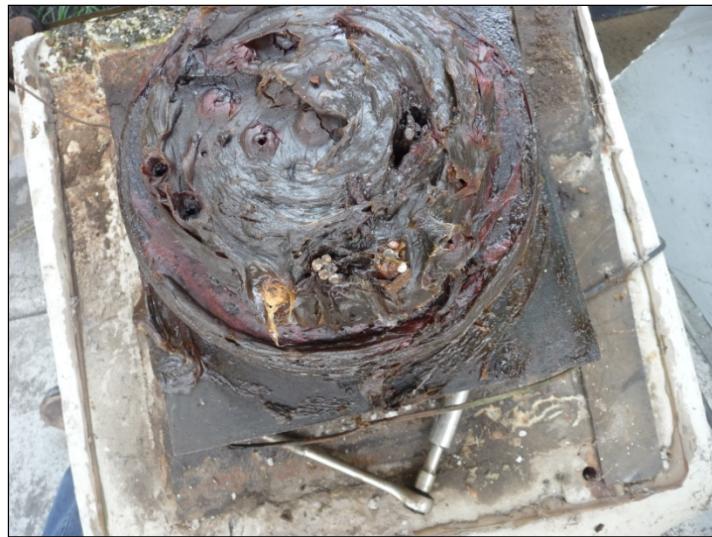
Figure 6-10. Water exits anchor heads through wedges and missing king wires.

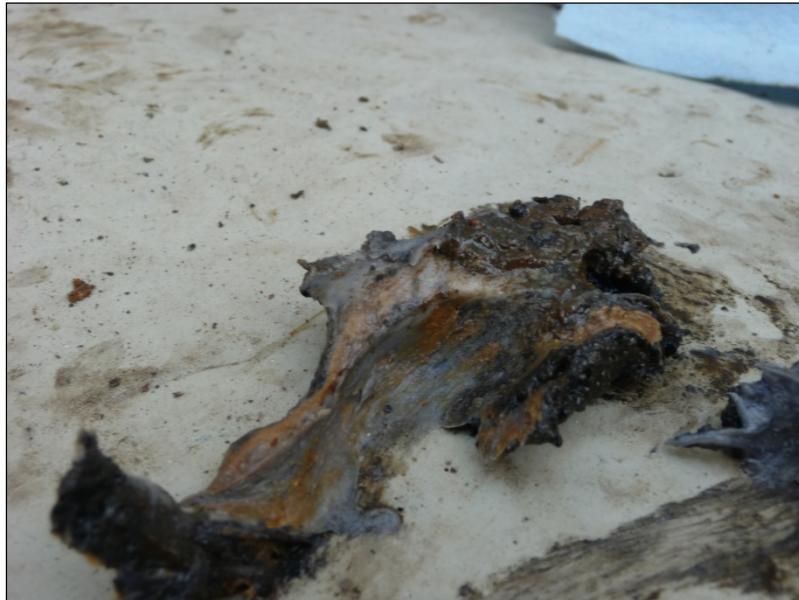
Found inside the tubes was some grease that appeared less contaminated. The red staining in the grease was obviously corrosion product (Figure 6-11). The black was believed to be mildew or some other growth contamination. Samples were to be analyzed for mechanical (acoustical) and chemical properties.

Figure 6-11. Grease with lower contamination (white, black, and red coloration).

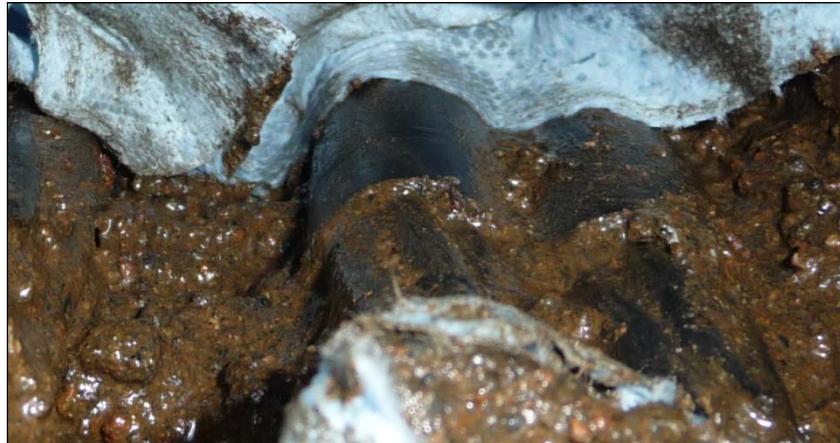
Figure 6-12 shows cable sheaths, of which little had been known. They appeared in good condition, with no signs of deterioration. As shown in Figure 6-13, no grout was detected in the trumpet section. A 3-ft feeler was used to verify that grout was not where it shouldn't be (at least 18 in. into the trumpet section). The removed anchor heads were being sent to ERDC-Vicksburg for further analysis. One speculated finding from this trip was the two analyzed anchor heads might have stopped taking grout during construction, explaining the absence of grout in the trumpet section. It also might

Figure 6-12. Cable sheaths with no signs of deterioration (3/4-in. diameter).

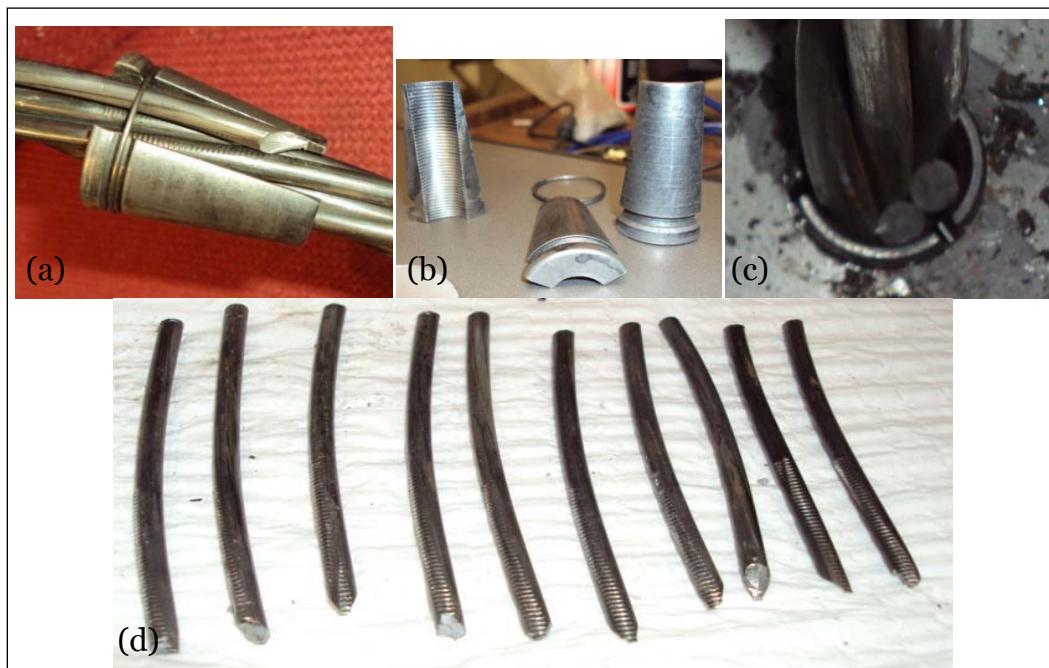
Figure 8-2. Common perimeter wire failure at wedge tip.
